R. A. HOFFMANN ENGINEERING, P.C.

February 23, 2018
3420-LTR-01

RE: Haldane Central School District Steam System-Pipe Failures

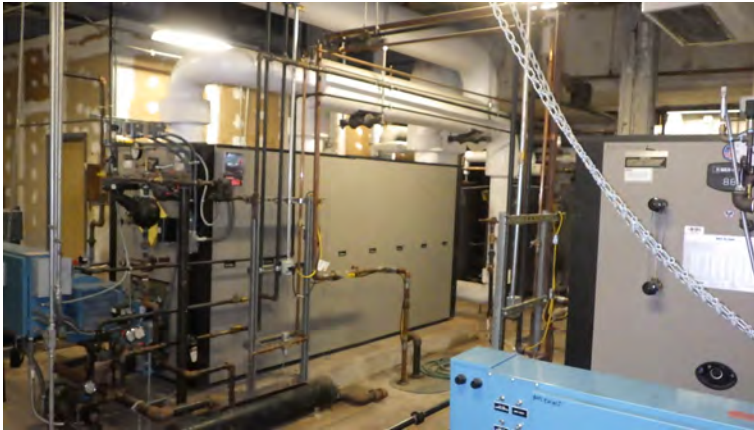
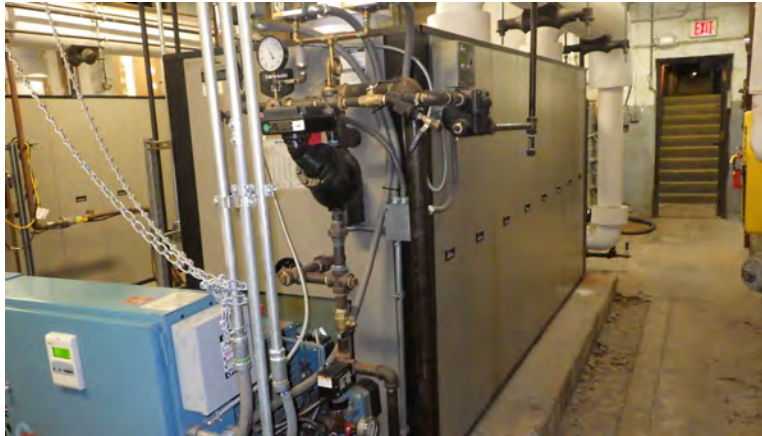
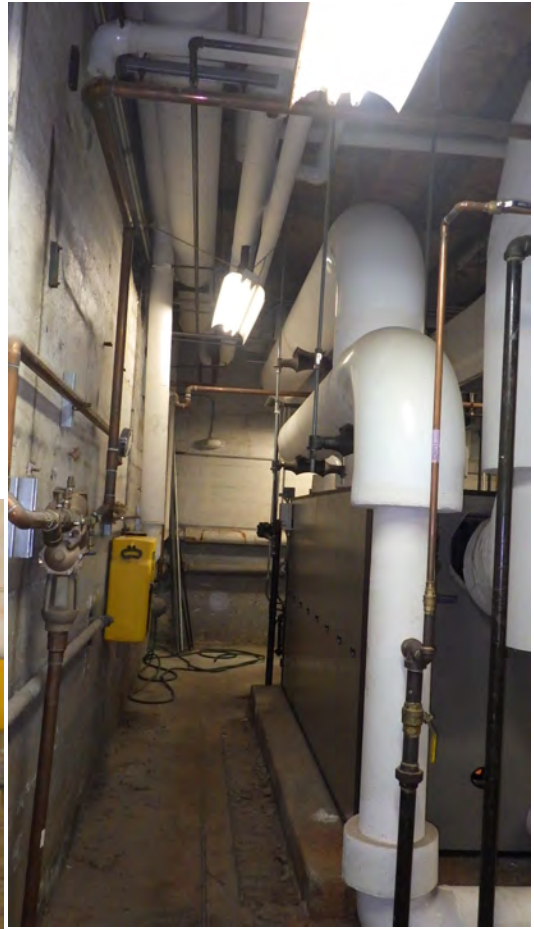
Figures 1. **Boiler Room**: Figures 1A and 1B show the recent boilers. Figure 1C shows the insulated steam pipe headers and main distribution piping.

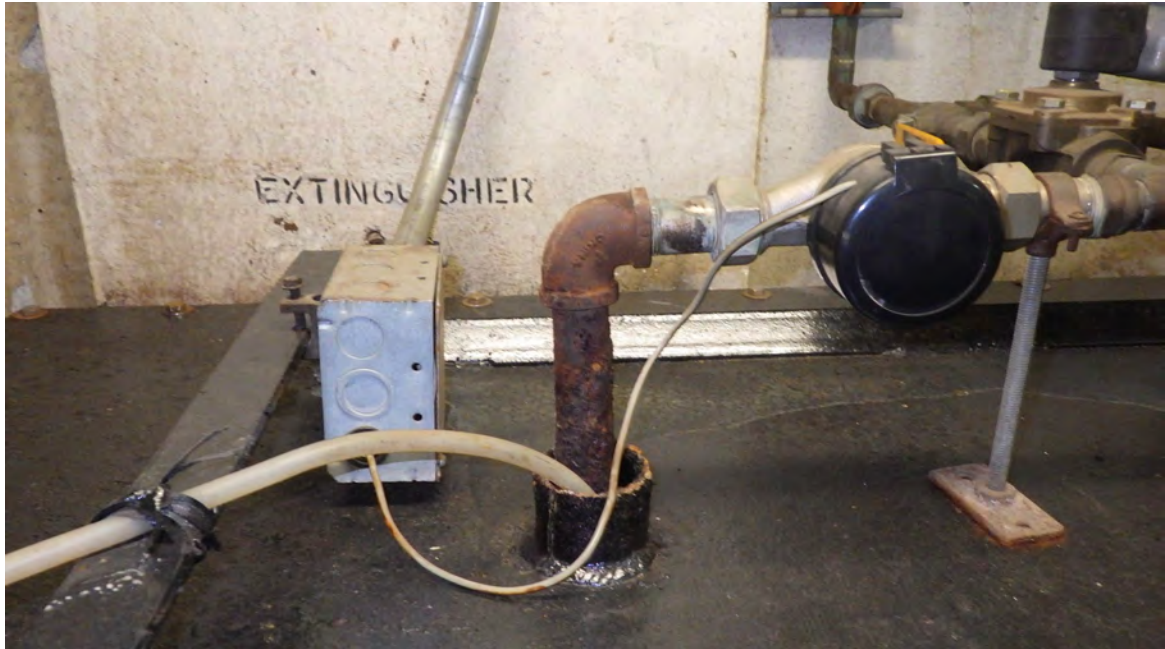
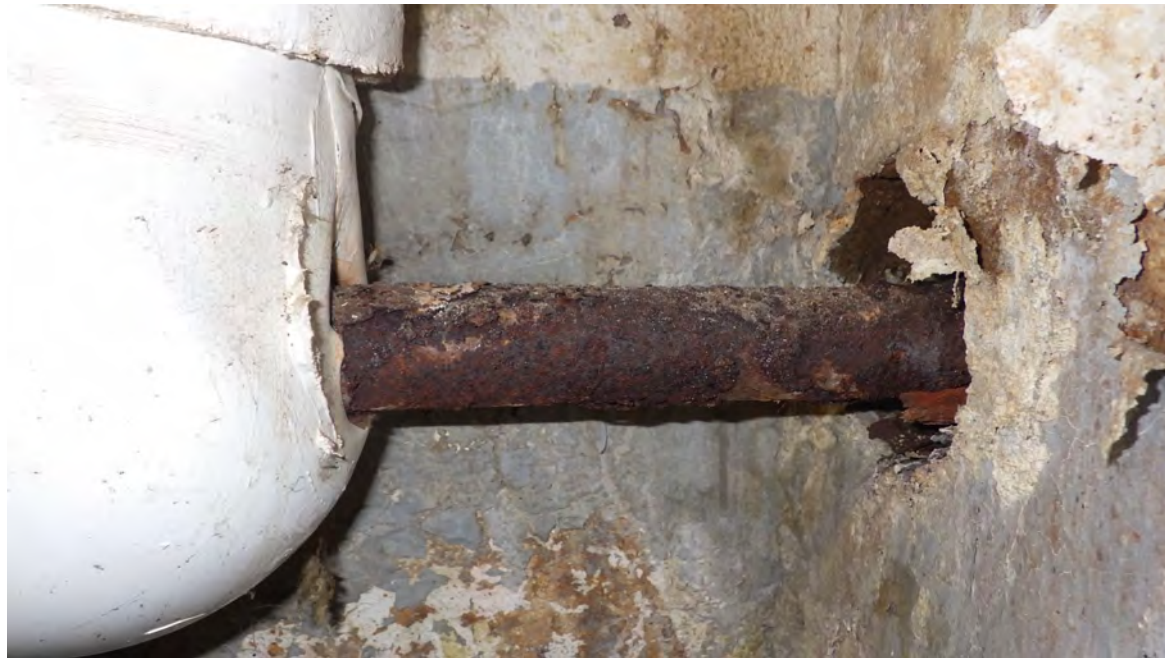
The source of the wetness responsible for the corrosion for the samples presented for examination was not identified. It is interesting to note there was a section of steam pipe distribution that was understood to be original and exhibits exterior corrosion similar to the samples provided. Please see Figure 2A and 2B.

Figures 2A & 2B. **Boiler Room - Corrosion on exposed piping.** Figure 2A highlights a small section of steel piping associated with the Condensate Treatment Feed system an unavoidable hot and aggressive environment. Figure 2 B represents a section of steam distribution piping that is believed to be original. Note the exterior corrosion present.

It would be our recommendation to conduct a greater survey of the steam system. As an example trace out piping within the crawlspace. Expose piping concealed by either wall or ceiling for a visual inspection. Additionally, the sources of wetness responsible for the corrosion should be determined and used a predictor for the rest of the original piping

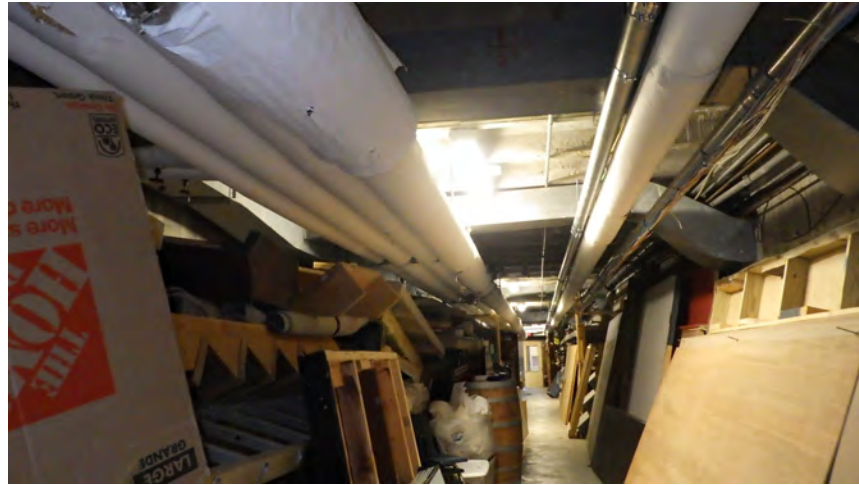
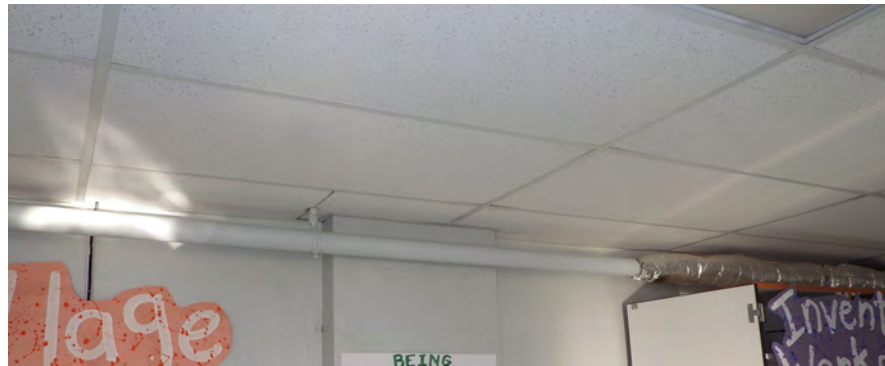
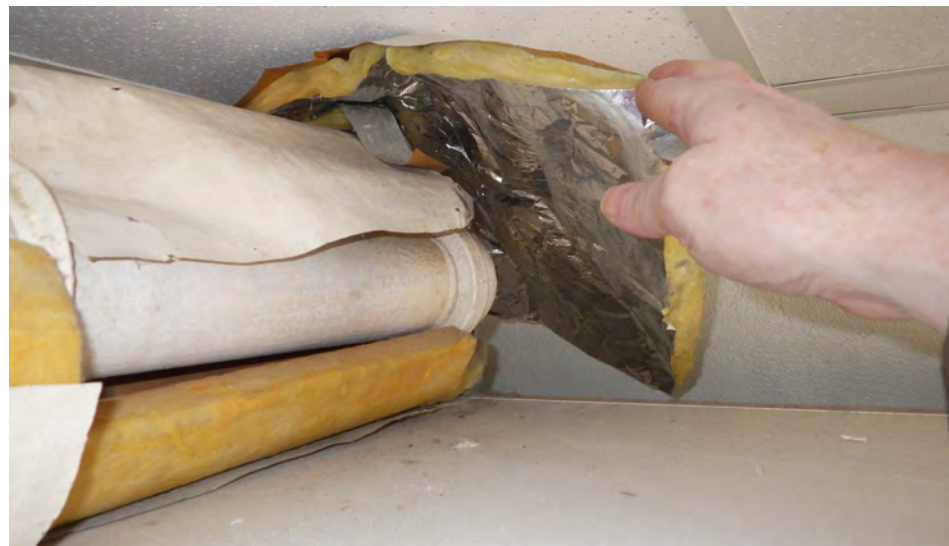
Figures 3A,3B and 3C. **Service Corridor/Art Room B5** Figures 3A notes thje service corridor and the well insulated lines Figures 3B and 3C reveal the condition of the partially exposed steam line within the art toom. Figure 3C is of the elbow. Not corrosion was noted.

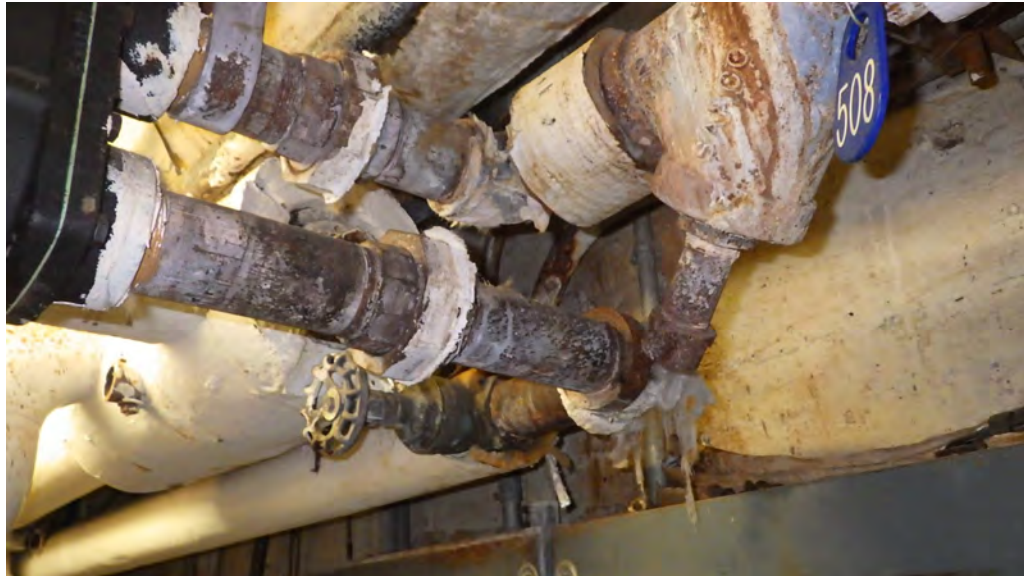
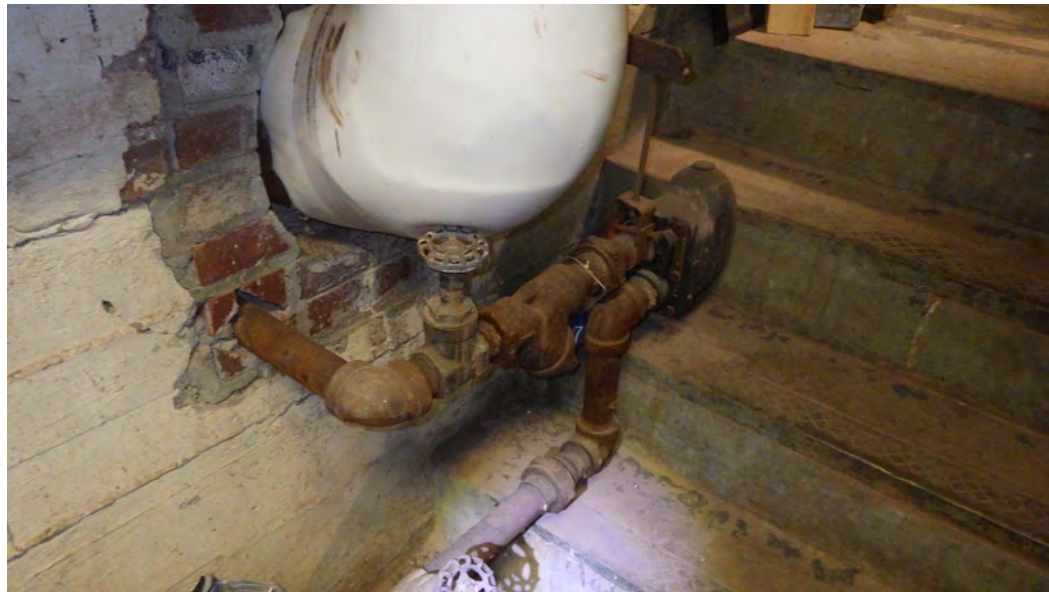
Figures 4A and 4B. **Exposed Steam piping - Steam/HW Room** Figures 4 reveals the exposed condition of a portion of uninsulated piping within the Steam/HW HX room that provides HW heating to the 1960's era expansion space. Extensive corrosion is not present.

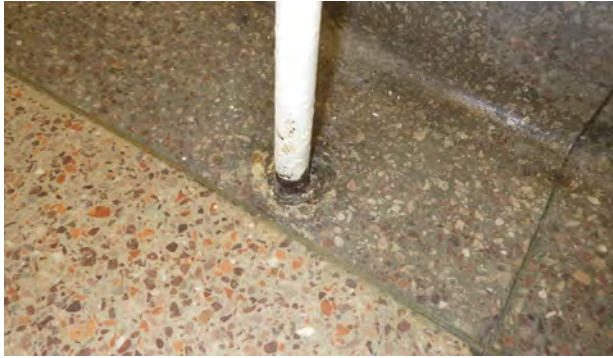
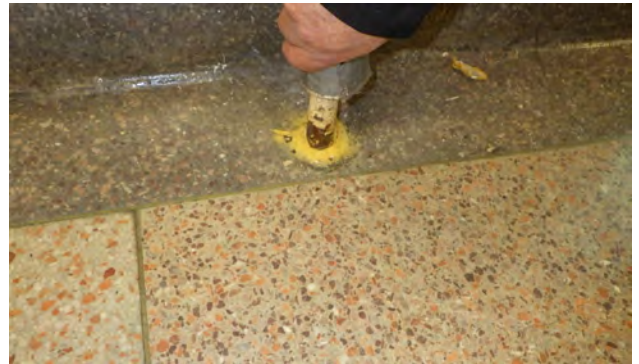
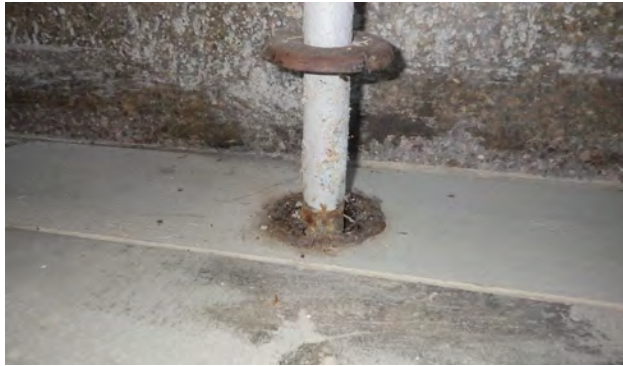
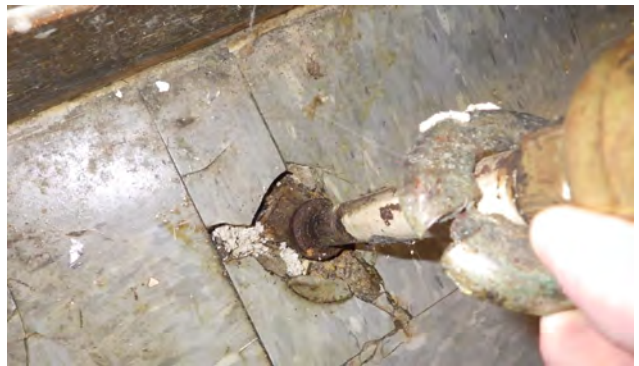
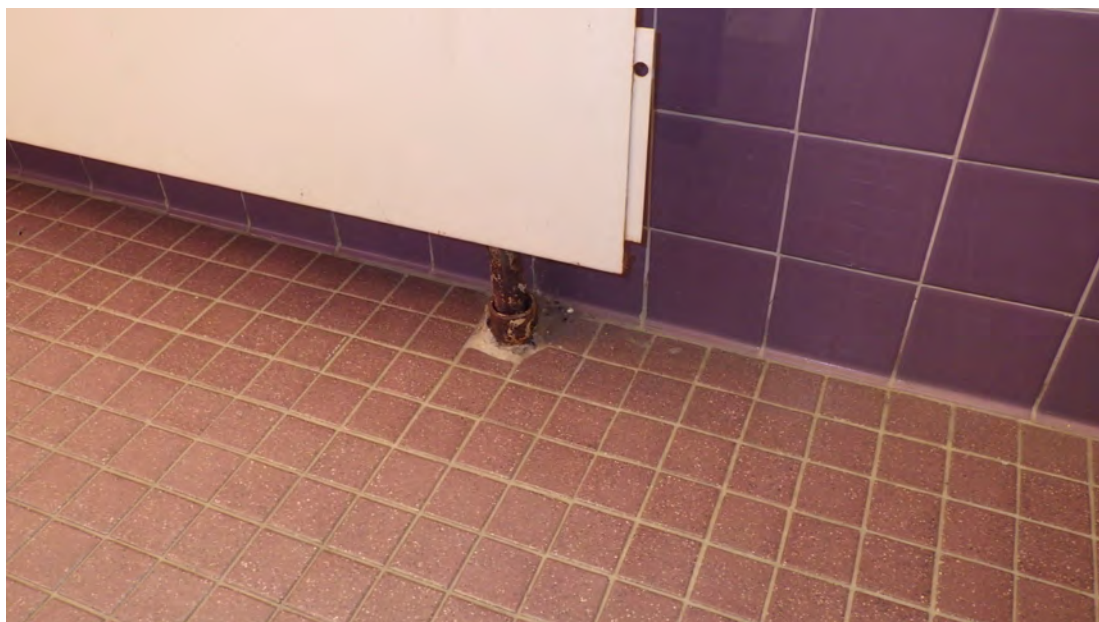
Figures 5. **Typical Radiator Pipe Penetrations:** Figures 5A thru, 5E reveal the typical floor pipe penetrations. No visible pass thru visible to the lower floors. Figure 5E is of the 1st Floor ES Girls Room. (Item # 11 on the ITable1) A sleeve was provided to protect the pipe.

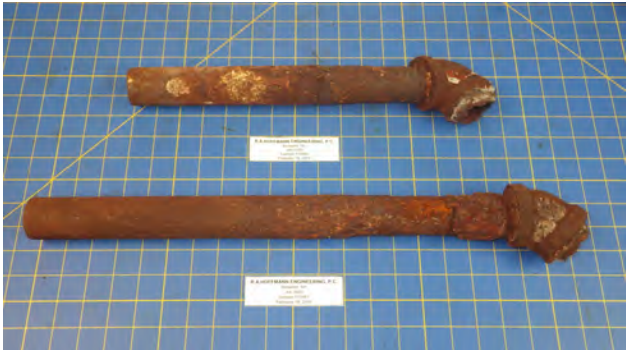
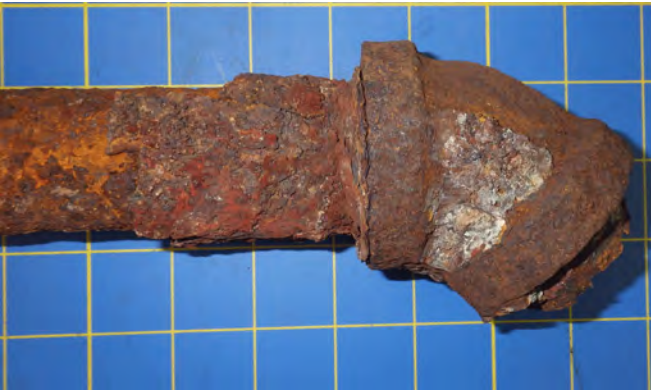
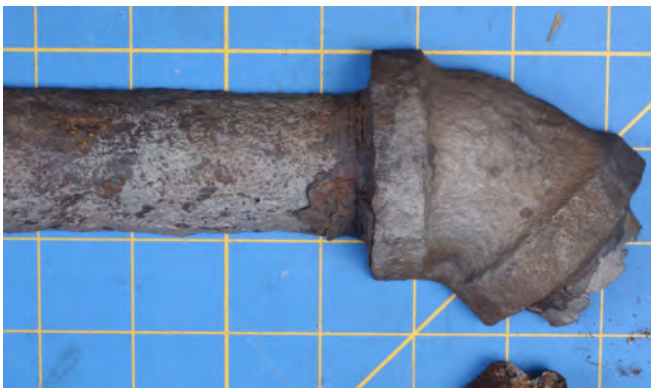
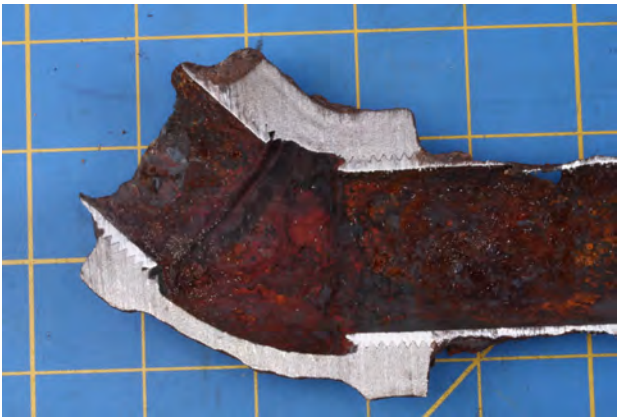
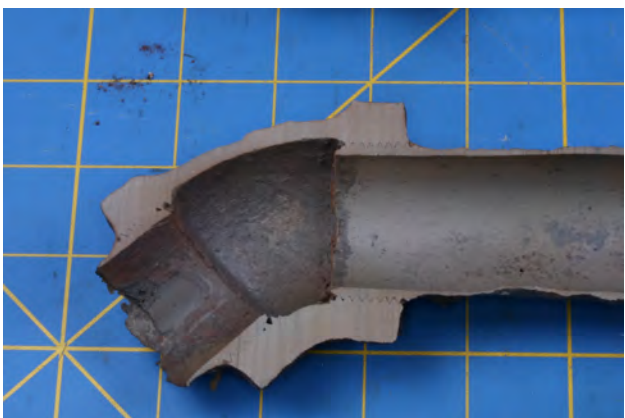
1. Severe corrosion damage exhibited on the exterior of the elbow connections
2. Failure (leaks) occurred at the threaded pipe/elbow interface.
3. A hole approx 1/8" diameter was observed approximately 6" from elbow connection.
4. Severe corrosion extends approx. 10" away from the elbow connection
5. Beyond the 10" distance the pipe was observed to be in good condition with only minor surface corrosion present on both the exterior and interior pipe surfaces.
6. Corrosion appears to be limited to the exterior of the pipe.
7. The interior condition was acceptable.

The cause of the observed failures as represented by samples 113950 and 113951 is outside in corrosion. This occurs when the exterior of the pipe becomes wet and is allowed to remain wet as is the case under insulation. Failures occurred at the elbows as these typically present breaks or ends of insulation that allow water/moisture to enter the pipe surfaces. This process can be cyclical and can take years to failure.

Figures 6. **Sample 113950 and 113951** Figures 5A, documents the samples as recieved. Figures 6B,C,D, and E reveal the exterior and interior of the sample 113951 after sectioning as well as before and after media blast cleaning.

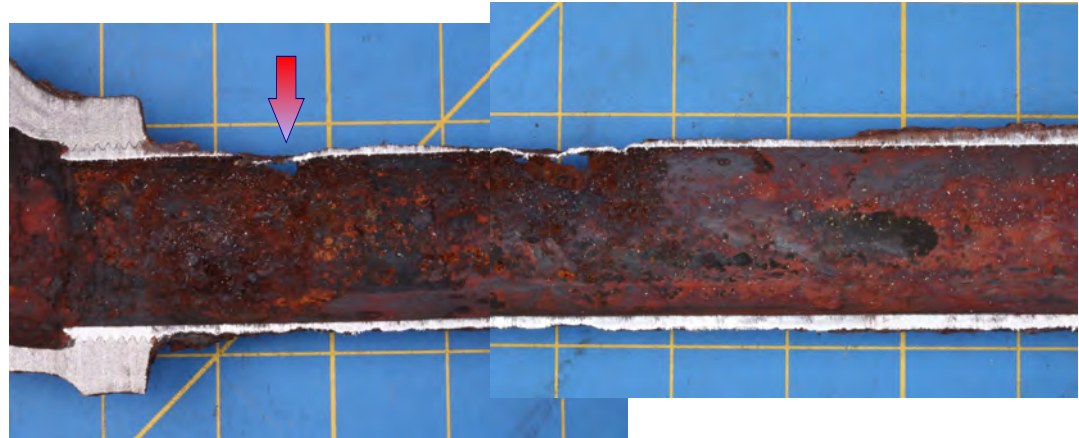
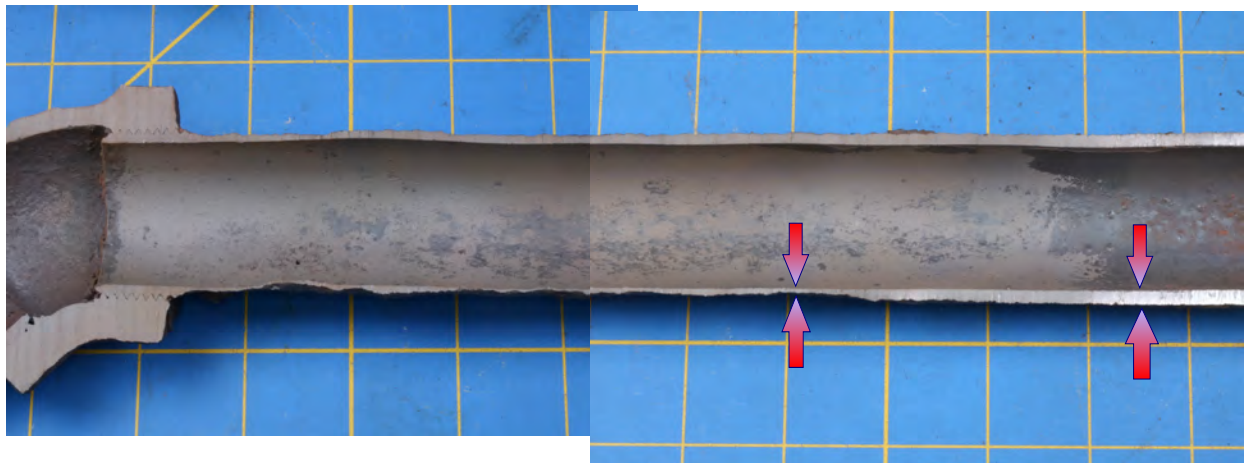
Figures 76. **Sample 113951** Composite images 7A, 7B reveal the interior of the failed pipe sample after being sectioned and. One half was cleaned. The variation in pipe wall thickness from thin (failed) to normal the further away from the elbow (figure 7B arrows). Note the perforation in 7A.
