BARILE GALLAGHER & ASSOCIATES

HALDANE CENTRAL SCHOOL DISTRICT
ELEMENTARY – MIDDLE SCHOOL
2018 PRE-BOND EVALUATION

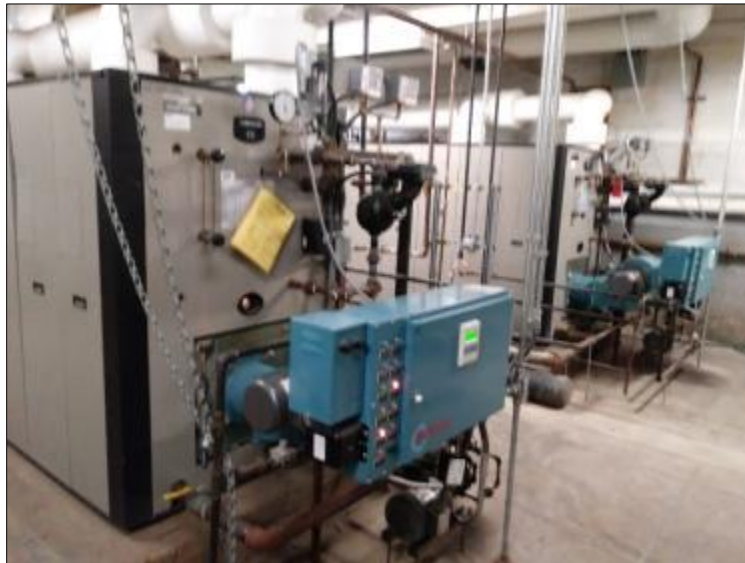
Figure 1: Recently Installed Boilers

The steam boiler plant was recently replaced with new cast iron sectional boilers. The boiler feed pump had been reportedly installed in 1973 and is well beyond its useful life (15 years per 2015 ASHRAE Handbook).

Steam piping failures have been reported in the 1934 Building and in the 1979 Addition since 2006 and have continued through 2017. We expect this condition to continue unless a long term strategy is implemented.

1. Convert 1934 Building and 1979 Addition from steam to hot water. Convert existing boilers from steam to hot water and remove existing failing boiler feed pump. Provide base mounted pumps in Boiler Room for building hot water distribution. Eliminate steam to hot water converters and pumps in 1964 Addition Mechanical Room and feed 1964 Addition directly with hot water system in Boiler Room. Replace floor mounted unit ventilators that are approaching the end of their useful life in the 1934 Building with vertical energy recovery type unit ventilators that are capable of supplying ventilation air and exhausting air locally at each exterior classroom wall. Replace roof mounted air handler in 1979 Addition with the same vertical unit ventilators in each classroom. Provide hot water distribution piping and finned tube radiation throughout the 1934 Building and 1979 Addition. New vertical unit ventilators are much quieter than floor mounted unit ventilators. This approach will allow the steam system to remain in operation while a good portion of the hot water system is installed. It will also allow for the steam piping in the tunnels to be abandoned in place and reduce the amount of asbestos abatement. The District will continue to see steam piping failures without a long-term solution. Failures can cause costly damage to the building as well as potential safety hazards. Providing a new hot water distribution loop at the same time as classroom ceilings are replaced will prevent redoing ceiling work in the future for pipe installation.

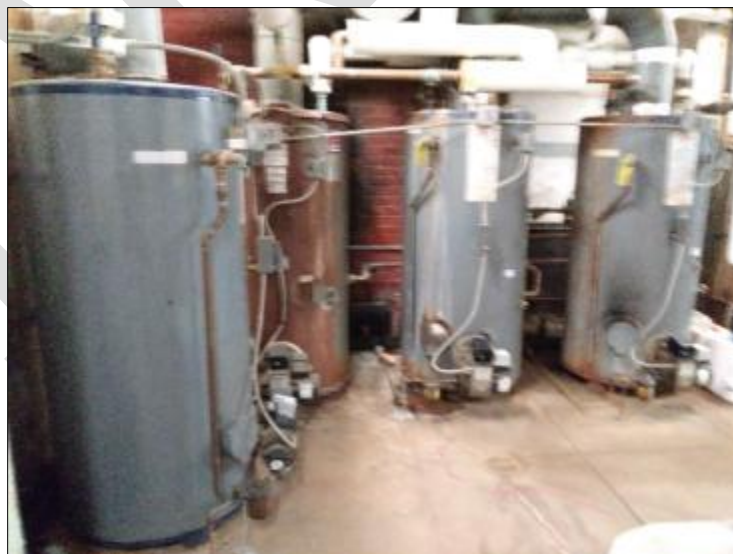
Figure 2: Domestic Hot Water Heaters

There are four domestic hot water heaters. One serves the lavatories and sinks throughout the building, one serves the Kitchen and the other two have failed.

2. Replace existing domestic hot water heaters with two high efficiency propane type condensing hot water heaters. One would serve the Kitchen and the other would serve the rest of the building.

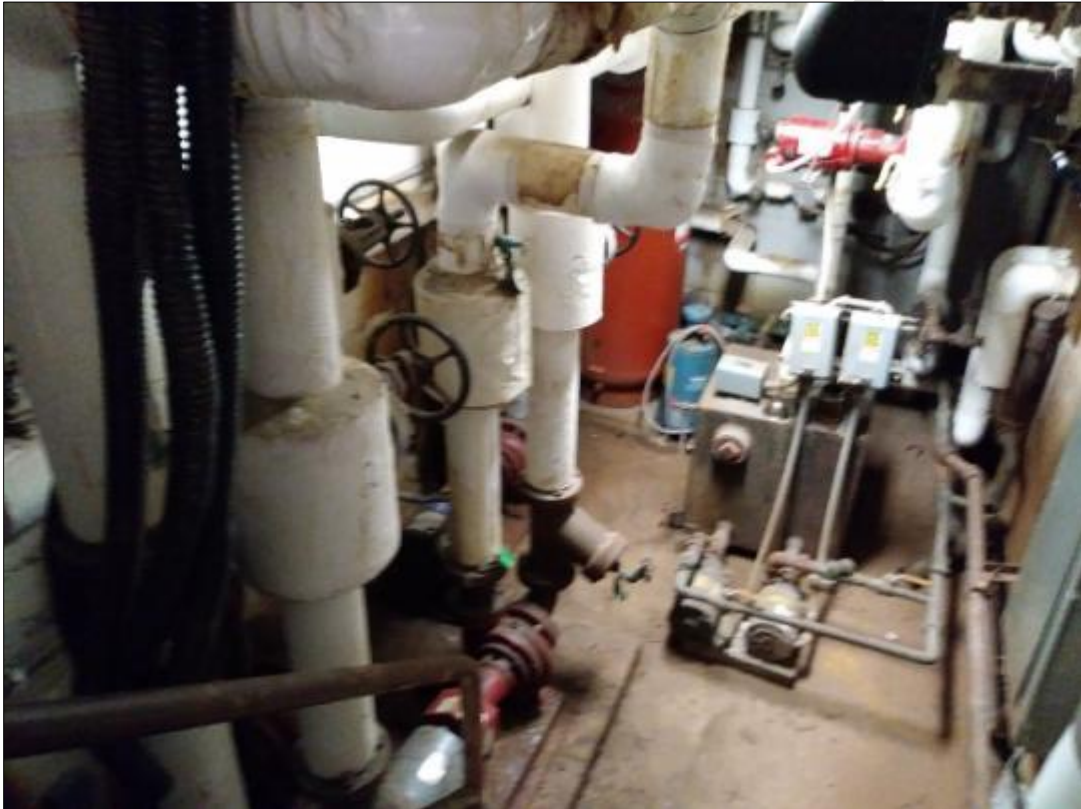
Figure 3: 1964 Mechanical Room

The 1964 Addition has two steam to hot water converters and hot water pumps in a separate Mechanical Room to heat the 1964 portion of the building with hot water. Two of the original pumps have failed and have been abandoned in place. There are also two in-line pumps that serve separate zones in this portion of the building. The steam to hot water converters have outlived their useful life (24 years per ASHRAE 2015 Handbook).

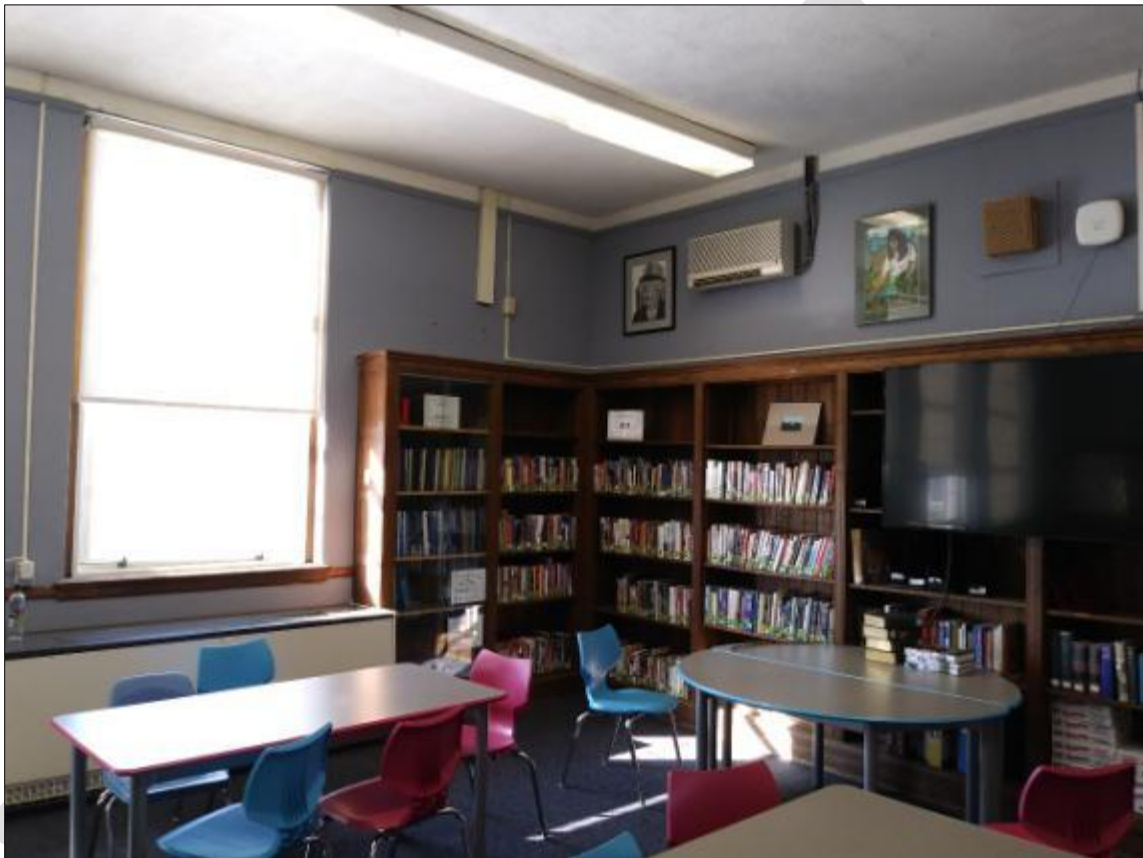
Figure 4: Library Floor Mounted Unit Ventilator and High Wall Ductless Split AC

The Library is served by 2003 vintage steam unit ventilators and ductless split systems for air conditioning. The ductless splits do not provide outdoor air to the space and reportedly fall short on cooling on very hot days. If the unit ventilators are operating during the warmer months to introduce code compliant outdoor air at the same time as the ductless splits are operating, humidity could condense out onto surfaces in the space.

5. Provide a new ducted rooftop unit with a hot water coil in the ceiling of the Library to provide heating, cooling and ventilation per current code and NYSED standards.

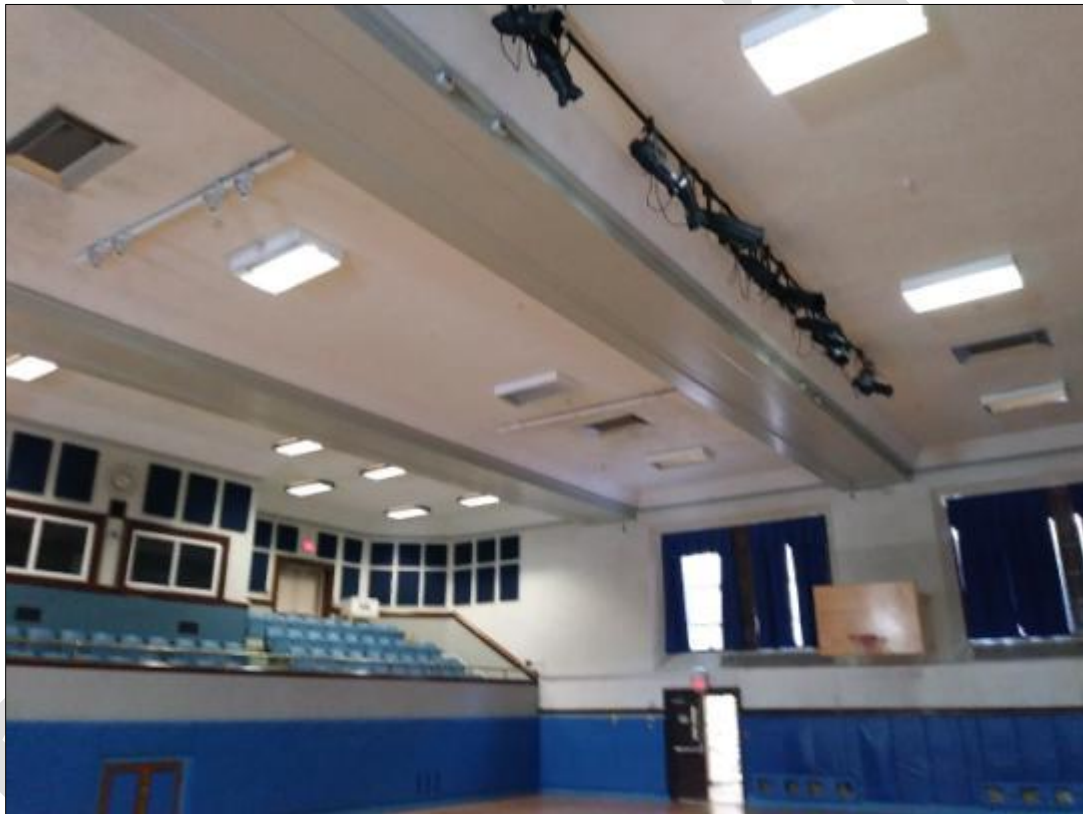
Figure 5: Gymnasium Rooftop Unit Ceiling Outlets

The Gymnasium in the 1934 Building has perimeter steam radiators for heat. The original steam air handler in the rooftop Mechanical Room has been abandoned in place. Gravity exhaust shafts behind the balcony area would relieve the outdoor air formerly introduced by the abandoned air handler. Windows are the only source of ventilation in the cooler months which does not conform to current NYSED standards. Five rooftop units above the space provide cooling and ventilation in the warmer months only. Four of them blow air from one outlet each in the ceiling without distribution. The fifth one is ducted behind the Stage. They are reportedly approaching the end of their useful life.

3. Replace the Gymatorium steam air handler with a new hot water air handler in the existing rooftop Mechanical Room that provides outdoor air during heating and cooling mode. This will meet current code and NYSED standards. Provide a roof mounted condensing unit and eliminate the five cooling only rooftop units.

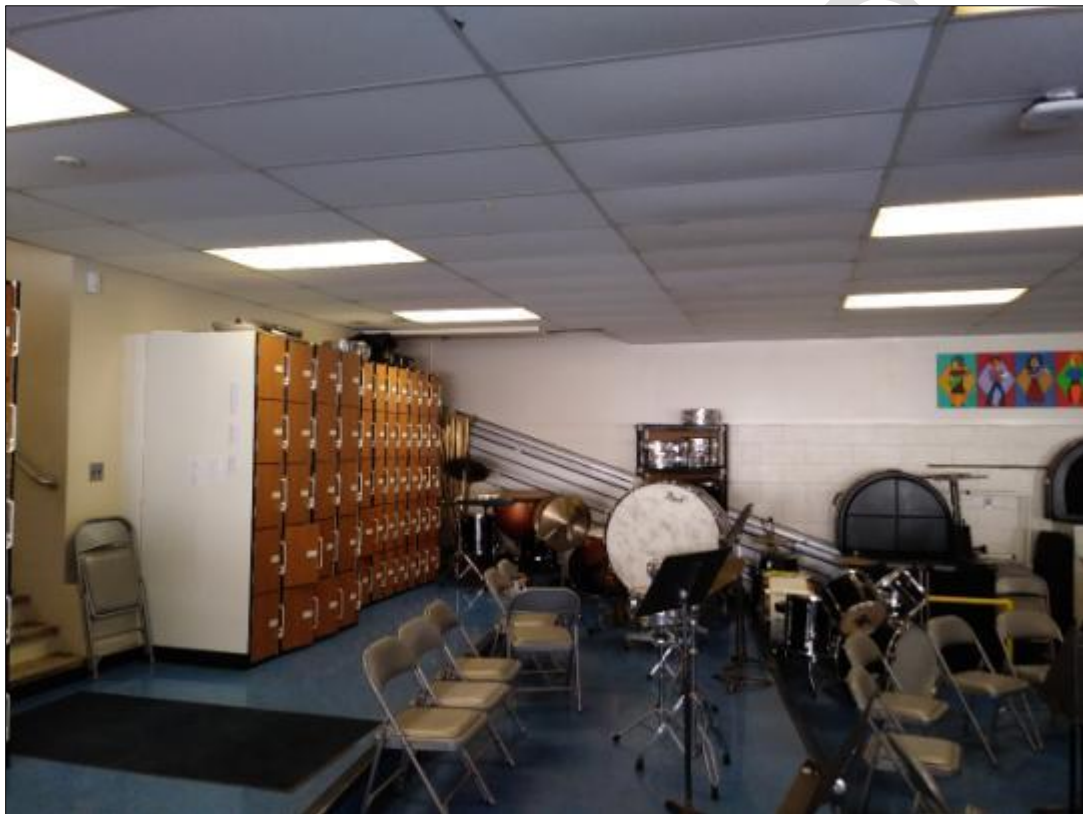
The Music Room off the Cafeteria appears to have had a unit ventilator at one time because there is an abandoned unit ventilator fresh air intake louver on the exterior wall. However, a cabinet heater has been installed in front of the blanked off intake. There is no powered ventilation introduced into the space which does not conform to NYSED standards.

Figure 6: Music Room with No Ventilation

4. Provide a new ducted rooftop unit with a hot water coil in the ceiling of the Music Room to provide heating, cooling and ventilation per current code and NYSED standards. A few solar panels may need to be removed or relocated.

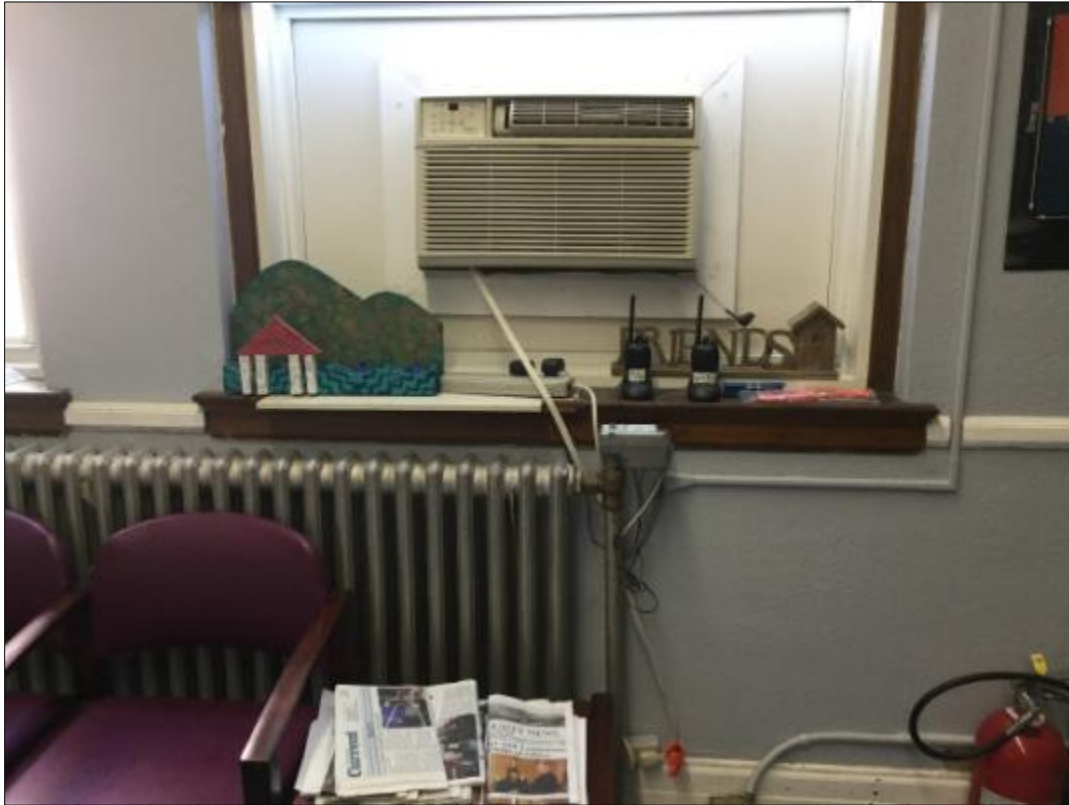
Figure 7: Main Office Radiator and Window Air Conditioning

The Main Office/Nurses Room have perimeter radiators and ducted exhaust. There are window air conditioners for cooling only. There is no powered ventilation to this space which does not conform to NYSED standards.

6. Provide new heat pump type split systems with outdoor air capability in the new ceilings in the Main Office and Nurse's Room to provide heating, cooling and code compliant ventilation and to meet NYSED standards.

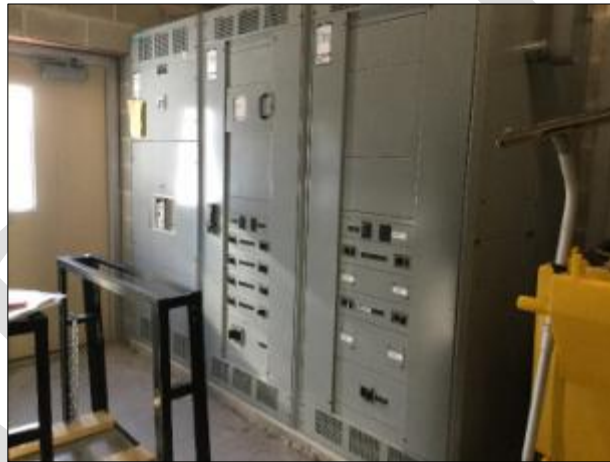
Figure 8: 2500 Amp, 120/208V, 3 Phase MDP

The main distribution board is adjacent to the Boiler Room on the ground floor. It is rated 2500 amps at 120/208V, 3 phase, 4 wire with a 2500 amp main service switch. The electrical service also has a built in surge suppressor and ground fault protection. Upon visual inspection, it was determined that there are two (2) 400 amp, three (3) 225 amp, three (3) 100 amp spaces for future work.

The capacity of existing service is approximately 900 kW and as per NEC and IBC, the building is allowed to use up to 80% of the capacity, which equates to 721 kW. From our visual inspection, there are at least 4 pole spaces available in each main distribution board for future proposed work. This amount to 597 kW spare capacity left for future work.

1. If the District decides to add Air Conditioning loads to the Music Room, Library, Main Office and Gymnasium, the existing electrical service will still have enough capacity for approximately 15 tons of air conditioning in the future.
2. Provide additional branch circuit panels for convenience receptacles being added to classrooms

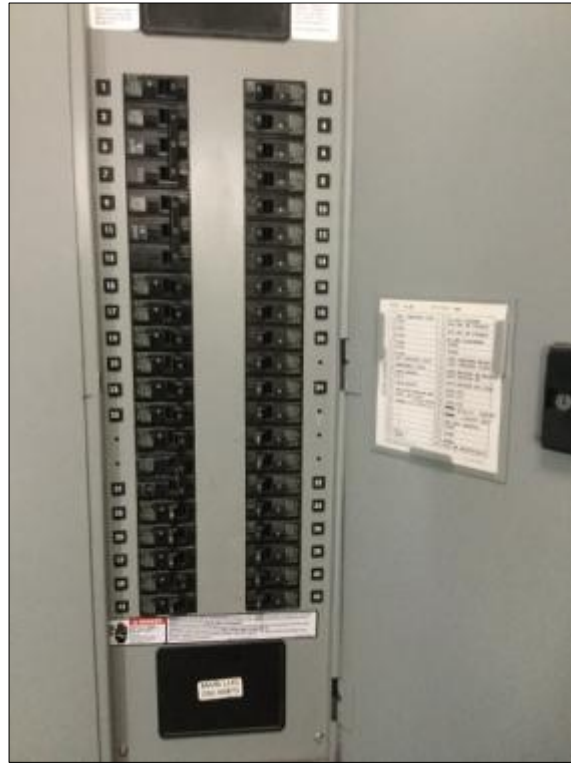
Figure 9: Electrical Panel with Spare Capacity

The majority of existing panelboards have minimum spare capacity to support additional loads if future expansion or additional receptacles are required in classrooms, offices, etc.

Lighting and power panelboards are circuit breaker type throughout. The 1934 portion of building contains few panelboards and perhaps feeders that have outlived their useful life. The life expectancy of electrical panelboards and feeders is 50 years. Most of the panelboards were retrofitted from 1964 and thereafter. In 2005 three (3) new panelboards were added, intended for technology infrastructure power distribution. The lighting and power panelboards are in fair condition including the feeders. In the next 7 years, a number of existing panelboards and feeders will have outlived their useful life. Infrared testing on all original panels and insulation resistance testing on all feeders is recommended. As the nature of electrical loads change year after year, periodic testing of panelboards and feeders can give insight to the condition of equipment prior to any malfunctions.

All switches and connections should be inspected, exercised and connections tightened for proper operation. Depending on results, panelboards and/or feeders may require replacement.

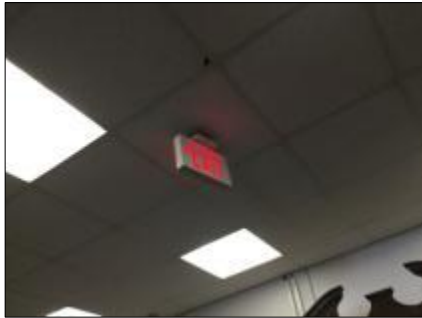
Figure 10: Typical Exit Lighting

The exit lights are energy efficient LED types. There appears to be a lack of coverage in some of the public areas. Some of the exit signs appear to be damaged. The damaged lights need to be replaced with code compliant LED type exit lights and new exit lights need to be added in some areas.

1. Add emergency battery packs in areas where they are lacking.
2. Add emergency egress lighting at every door.
3. Replace damaged exit lights and add exit lights in areas where they are lacking.
4. Replace lighting in all classrooms where ceilings are being replaced.
 - Probable Cost based on the installation of nine (9) 2' x 4' fixtures in each room.
5. Add Receptacles in all classrooms.
 - Probable Cost based on the installation of six (6) duplex receptacles in each room.

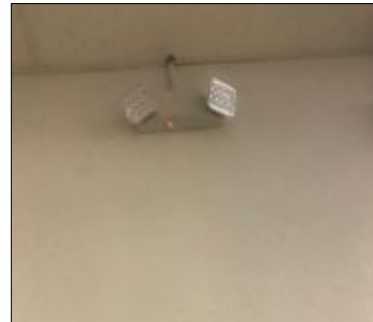
Figure 11: Typical Emergency Light

Emergency lighting is accomplished via wall mounted emergency battery packs. The National Fire Protection Agency (NFPA) requires a minimum of one foot candle of illumination. It appears there is inadequate quantity of emergency lighting fixtures throughout. The measurement of foot candle can be verified by using a light meter to determine actual foot candle levels.

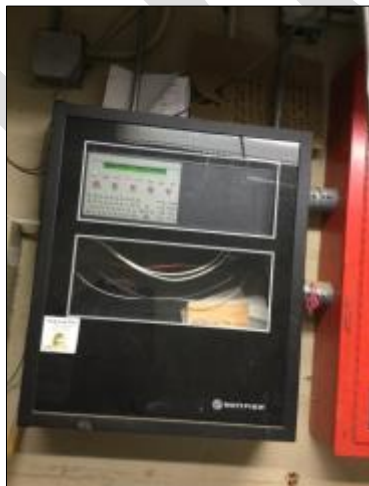
Figure 12: Fire Alarm Control Panel

The existing fire alarm system is an addressable system installed in 2004. The Fire Alarm Control Panel manufactured by Notifier model #NFS-640 is located in the basement outside the Boiler Room.

When the system was upgraded devices were replaced, but not upgraded to meet today's Americans with Disabilities Act (ADA) standards. Mounting heights, quantities of manual pull stations and quantities of visual indicating devices do not meet current code. Smoke detectors and heat detectors coverage is not adequate. The smoke detectors in the 1979 Addition are original to building construction and are the non-addressable type. The existing elevator does not have elevator recall. The roll down gate between the Cafeteria and Kitchen is not connected to fire alarm system. The District has not employed the services of a central station monitoring company. All trouble and fire alarm signals encountered by the fire alarm system automatically alerts the local authorities.

1. Replace the entire Addressable Fire Alarm System in building. Current system is not code compliant.
