August 10, 2018

3420-LTR-03

RE: Haldane Central School District Steam System – UT Measurements – Follow-up

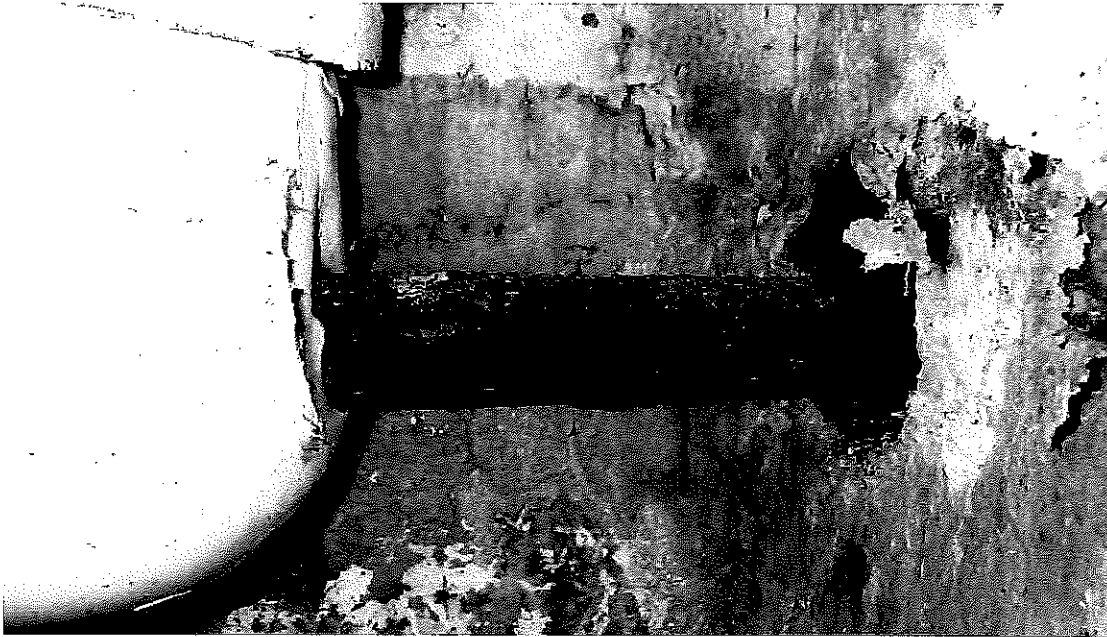
2. Sample 4, which feeds a small bathroom, exhibited evidence of long-term exterior corrosion.

Figure 1. **Boiler Room:** Sample Pipe #4 - Bathroom Feed. This pipe section was uninsulated and exhibited exterior corrosion. The tabulated wall thickness measurements for this pipe did not reveal a significant corrosion rate or wall loss.

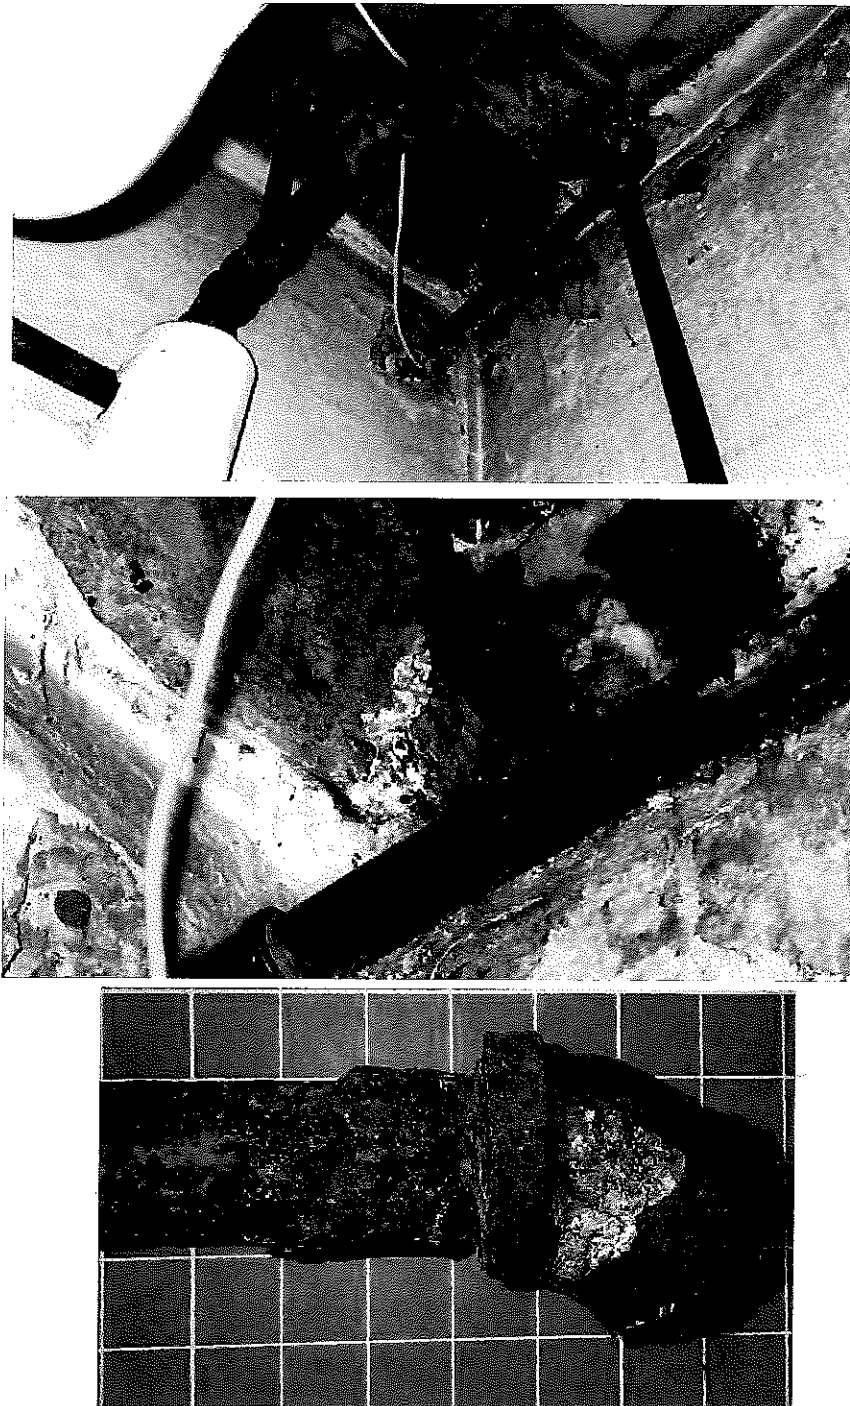
1. Proposed Sample Location 3 which could not be reached. Two adjacent pipes within reach were measured instead. However, the exterior of the pipe looked severely corroded. Figure 2 shows the exterior condition and its similarity to the previously failed pipe section.

The piping locations measured all have very low corrosion rates, yielding remaining life estimates in the hundreds of years. The exterior surfaces of the pipes were all in excellent condition with the exception the pipe adjacent to Sample 3.

Figure 2. **Boiler Room - Corrosion on exposed piping.** Figures 2A and 2B show the NW corner of the boiler room at a location that has experienced corrosion in the past. Figure 2C is an example of the previous failure. Note the similar exterior condition.

Our recommendation would be to pre-emptively repair the pipe identified near Sample 3 and shown in Figure 2.

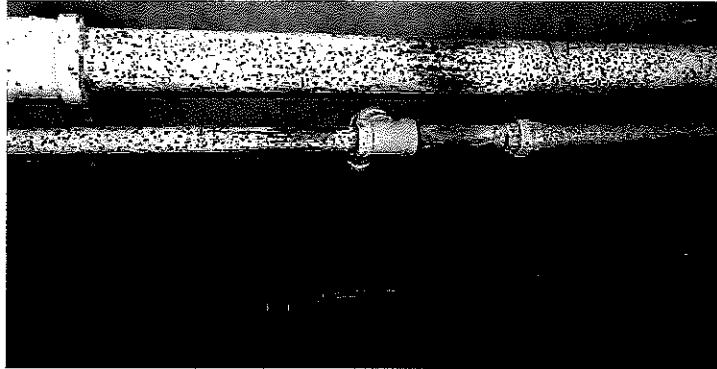
3A

Figures 3A,3B and 3C. **Samples 1A,1B,2A,2B and 5.** These figures reveal the tested conditions. Note the painted condition of Sample 1 and the well-insulated condition of Samples 2 and 5. No corrosion was noted.

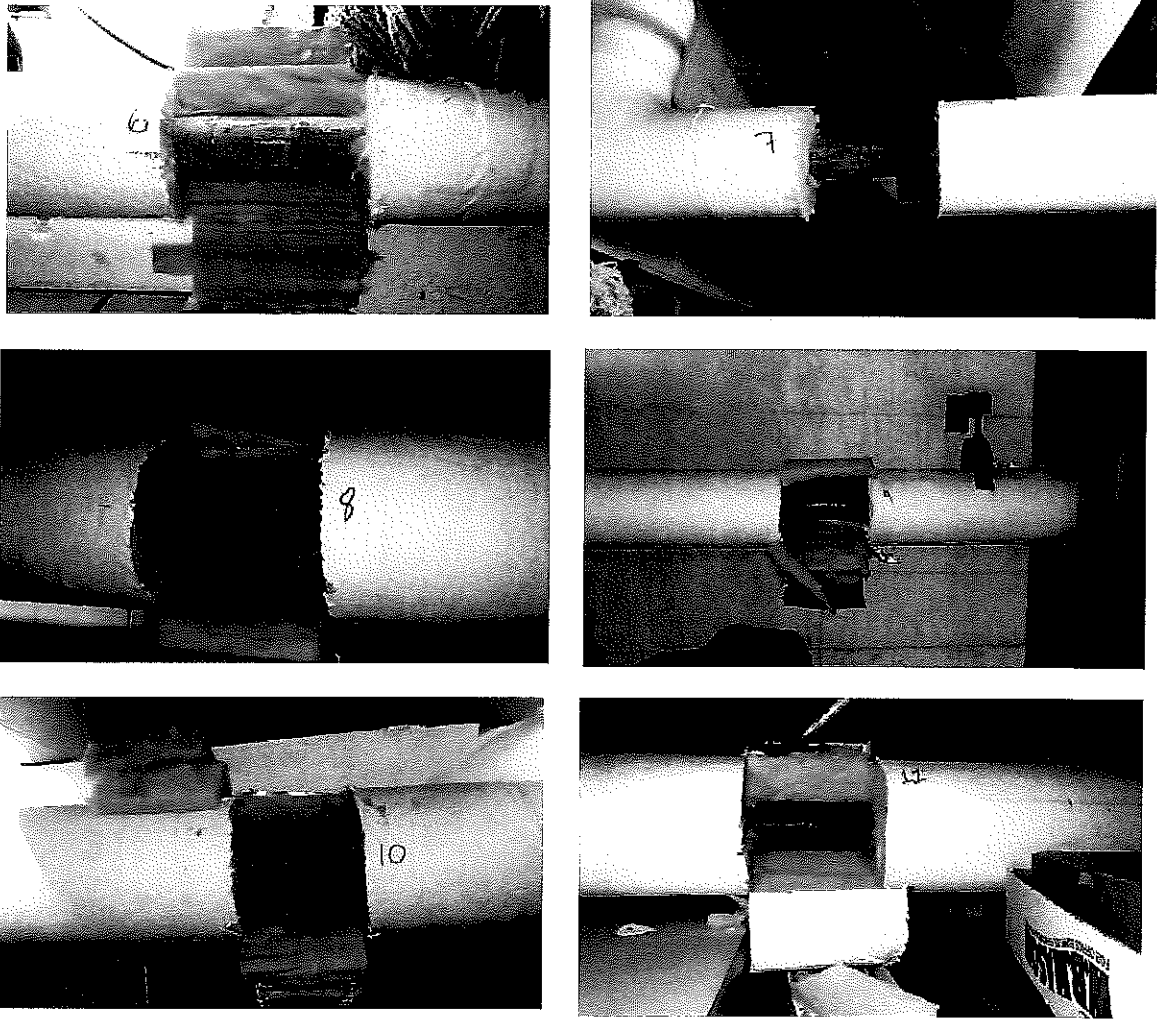
4A 4B  
4C 4D  
4E 4F

Figure 4. **Samples 6 to 11 – Utility Corridor** – Figure 4 reveals the excellent condition of the pipes tested along the utility corridor.

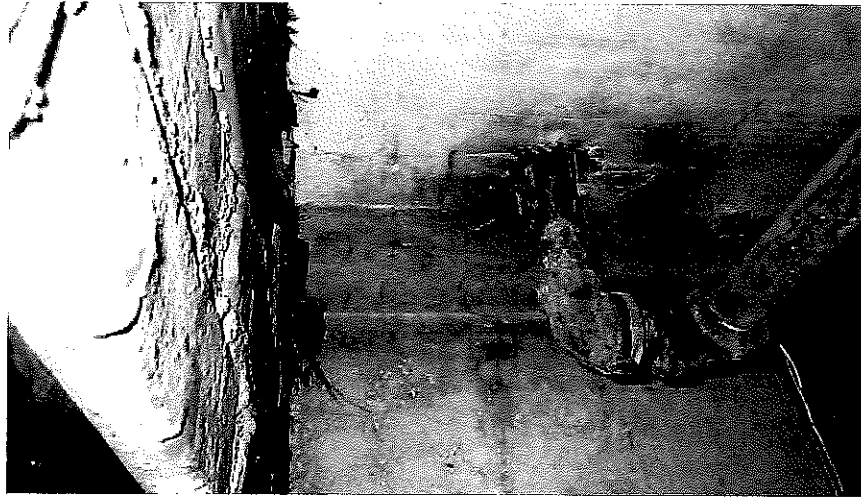
Figure 5. **Exposed Pipe:** Figures 5A thru 5C reveal Samples 12, 14 and 15. These were painted and in good condition. Sample 12 supplies the Boys Bathroom radiator on the main floor, Samples 14 and 15 serve the radiator on the 2<sup>nd</sup> level in the stairwell.
